febi 177699

Nissan Dualis 2007 > 2014, Note 1 2006 > 2013,
 Pathfinder 3 2005 > 2014, Qashqai 1 2006 > 2014

Clock Spring

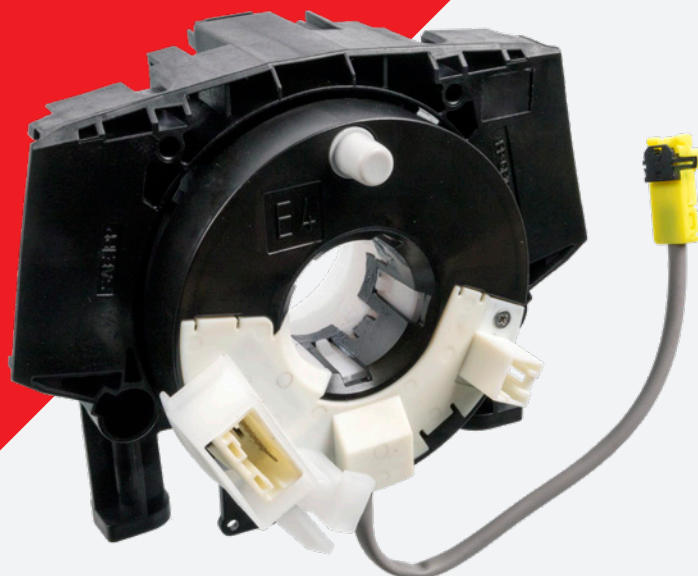
Upon starting the vehicle, the airbag warning light stays illuminated and there is a partial or full loss of functionality of steering wheel controls such as the horn or cruise control. Using a suitable diagnostic tester, the airbag control unit shows the fault code B1049 - 'drivers side front air bag igniter circuit/open circuit open'.

A coiled strip cable inside the clock spring results in constant contact being made between the wiring loom and the moving components on the centre of the steering wheel. Constant movement and climatic variations can cause fatigue, which ultimately leads to failure of the clock spring.

- Disconnect the battery and wait at least two minutes before starting work on any part of the airbag system.
- Make sure that the steering wheel is in the 'straight ahead' position.

- Remove the airbag module from the steering wheel. There are two holes on the reverse of the steering wheel; one on each side. Insert a blade-type screwdriver into each hole to release the internal clip and gently pull the airbag unit until it is free. Disconnect the yellow electrical connector and the connector with a green wire. The airbag module can now be placed in a safe location with the pad side facing upwards.

- Before removing the steering wheel, make sure that the indicator mark on the steering column is aligned with the 'V' marked on the steering wheel. If you cannot see these indicators, it is advised to add the marks yourself - this will make it easier to align when refitting the steering wheel later.
