to fit:
Suzuki Grand Vitara 1998>2005

Suzuki Grand Vitara - Camshaft Position Sensor

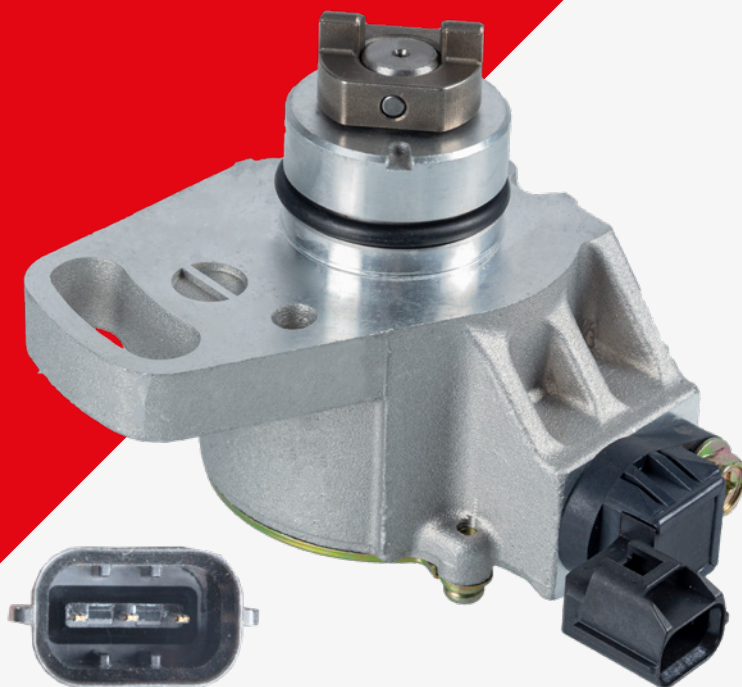
Engine fails to start.

No signal from the camshaft sensor, which is driven by the camshaft.

Note: When first diagnosing this sensor for possible signal failure ensure the exhaust camshaft is turning, whilst cranking, because of the common chain drive failures.

If replacing this Hall Effect camshaft sensor, the ignition timing needs to be checked and adjusted as necessary.

To set the ignition timing for this vehicle, the following procedure must be carried out.

- The engine should be at operating temperature and all loads switched off, idle speed 750+/-50 rpm.
- With the engine not running, set the vehicle in to its fixed spark mode, using suitable diagnostic equipment.
- Adjust the camshaft sensor by turning it to obtain the correct adjustment, checking with a timing light. 5°+/- 1°BTDC. Then tighten the fixing bolts.
- After checking the adjustment, end the fixed spark mode, stop and restart the engine.
- Recheck the ignition timing using a timing light, while the engine is idling, this should be 14°+/-2°BTDC.
- If the ignition timing is out of adjustment, recheck using this procedure.
