# febi 108906, 185548, 194035

Mazda 2 2016-, 3 2014-2016, 6 2014-2016,  
CX-3 2016-, CX-5 2013-2016, CX-9 2016-

## Anti Roll Bar Bush

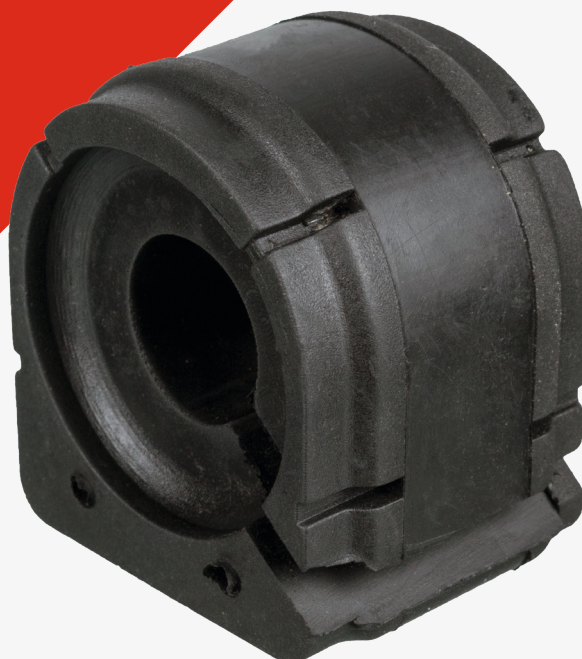
Squeaking noise from the suspension system when travelling over uneven surfaces after the anti roll bar bushes have been replaced or lubricated.

The bushes for the vehicles listed above are designed to be of a grip type which have been incorporated for noise prevention purposes. If any type of grease or lubrication is applied to the bushes during installation, it may create noise due to the bushes slipping on the anti roll bar.

To prevent noise from occurring, never apply any type of grease or lubrication to the front or rear anti roll bar bushes.

When replacing, only install these anti roll bar bushes when clean and dry and do not use any lubricant during the installation process.
