# febi 186664

Engine: 1.6 HDi

## Turbocharger

### Problem

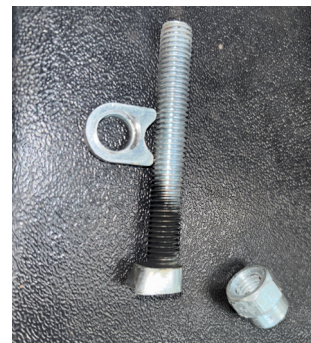
Fig. 1 Shows the soot on the thread of the clamp.

To install the turbocharger, fully remove the DPF and position it carefully, ensuring all connecting flanges are clean and free from soot and corrosion. Then fit the new turbocharger, secure it with a new clamp and test the system for exhaust leaks.
