# febi 186984, 189440

To fit: Various Citroën, DS, Fiat, Opel, Peugeot and Vauxhall models

Engine: 1.5 HDi

## Turbocharger

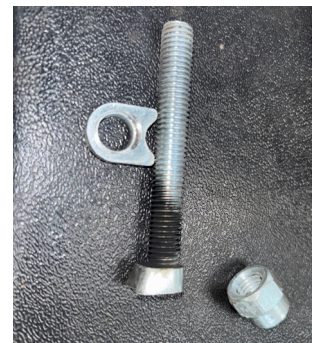
Fig. 1 Shows the soot on the thread of the clamp.
