# febi 187940

Engine: EA111 1.2 TSI

Turbo manufacturer:  
IHI F31CEG-SR005B-9V203 and  
F31CEG-SR006B-9V204

## Turbocharger

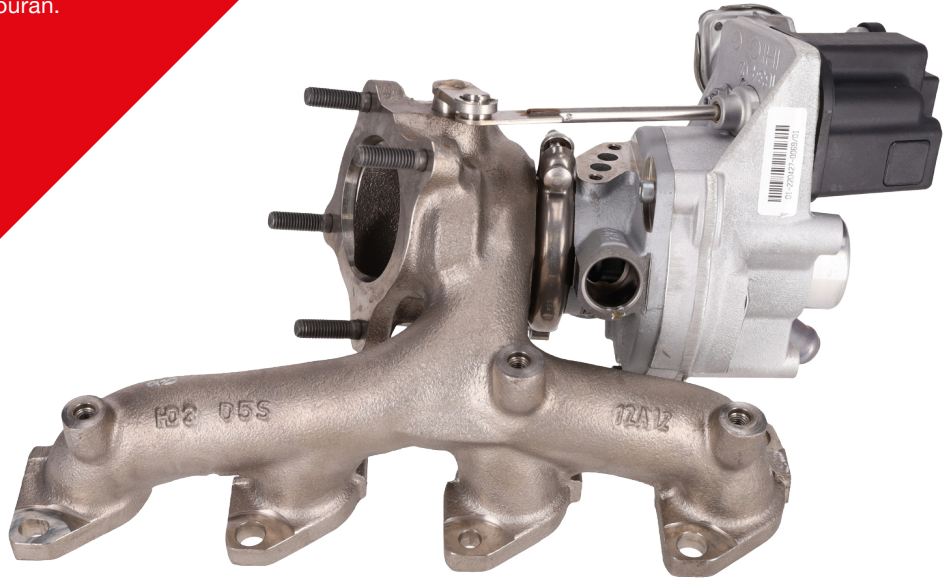
Engine has no power. Turbocharger actuator error and incorrect voltage values after replacement of the turbocharger.

Three different turbochargers were used during the production period of the 1.2 TSI EA111 engine. However, they are not interchangeable with each other. Differences in engine control unit software versions and/or lengths of the actuator linkage can cause the symptoms listed above.

The issue originated from the actuator rod being mounted directly above the exhaust flap, creating an uneven load that accelerated flap shaft wear and caused the exhaust flap to jam.

Compare the information on the original turbocharger's type plate before ordering a replacement turbocharger - this is vitally important to ensure correct fitment and operation.

After reinstalling the new turbocharger - if it is identical to the original - reconnect the battery, switch the ignition on, wait 10 seconds, then switch it off again. Repeat this process 10 times.

Carry out a 'capacitor reset'. Disconnect the battery for at least two hours, preferably overnight, and then hold the + and - terminals together to discharge the residual voltage of the capacitors. This will reset all learning values. After reconnecting the battery, switch the ignition on, wait 10 seconds, then switch it off again. Repeat this process 10 times.

Check the software version of the engine control unit. The last update from the vehicle manufacturer was from 2018, this allows for complete relearning of the actuators. Software updates can be carried out using the vehicle manufacturers' technical website and a suitable 'Pass-Thru' device, or by your local authorised Volkswagen Group workshop if required.
