# febi 40308

To fit:  
various Volkswagen, Audi, SEAT and Škoda models

## Auxiliary belt kit with belt tensioner and bolt

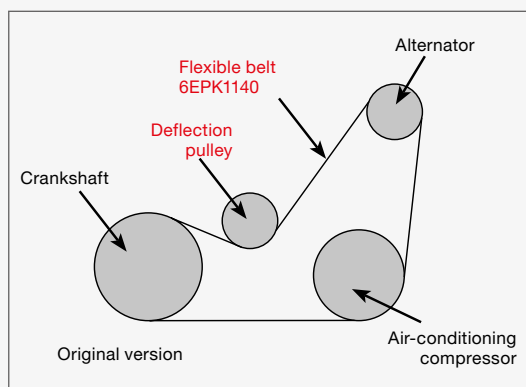
Figure 1

The original version of the auxiliary belt drive was driven by an elastic multi-V belt and a deflection pulley which suffered from wear, leading to insufficient tension of the auxiliary belt. (Fig 1) To improve the NVH (noise, vibration, harshness) characteristics, the vehicle manufacturer redesigned the components of the auxiliary belt drive.
