SPIN DOCTORS...

The Mitsubishi L200/Straker pick-up is well known for its ruggedness and load lugging capabilities. The example in question is a 2003 model, which is regularly put to work pulling a mini digger in addition to other ground work duties. The vehicle has covered over 225,000 kilometres and was still going strong; until a few months back.

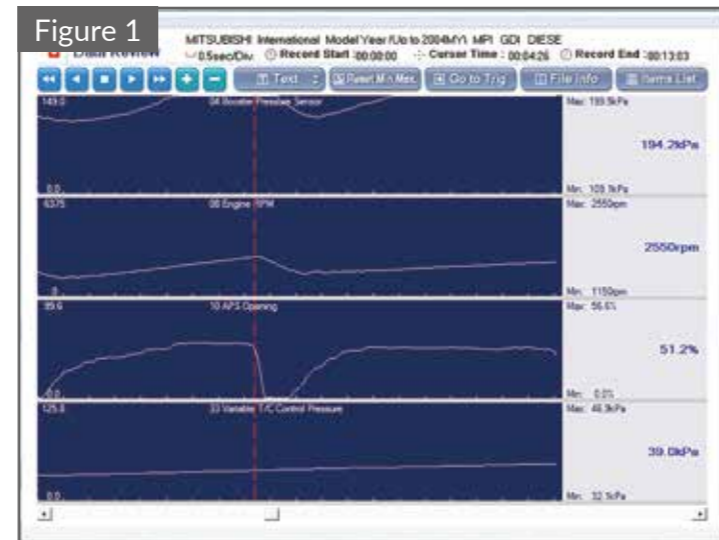
As the fault code told me there was an over boost problem but not much else, it was time for another road test. This time I set the diagnostic tool to record looking at the following values: Boost Pressure, Engine RPM, Throttle Position and Variable Turbo Charger

Control Pressure (Figure 1). Before the road test the fault code was logged and cleared, then driven to replicate the fault.

When the vehicle was back at the workshop I reviewed the data I had collected. First looking at the boost pressure reading, I discovered at several points it had exceeded its maximum boost pressure of 200kPa (2.0 bar). This was why the engine management lamp had come on, but what was causing it?

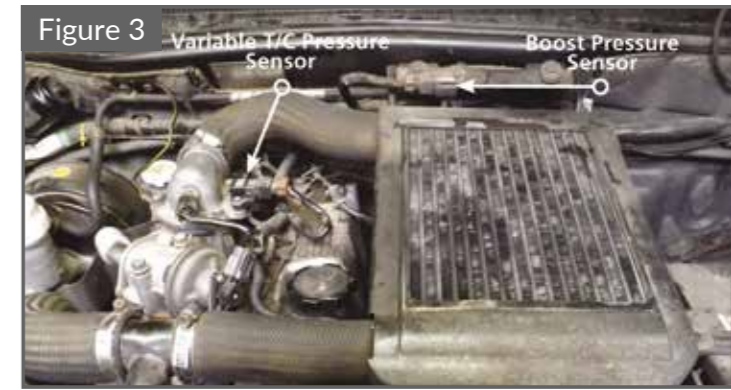
With a good vacuum supply and pipe work I ruled this out; I then checked the sensors (Figure 3) to confirm the measurements I was getting. I unplugged the vacuum pipe from each sensor and connected a hand vacuum pump – this was to test each sensor and at the same time compare the readings to the ones I was getting from the diagnostic tool. With both the boost pressure and the variable turbo charger control pressure sensors confirmed to be OK and reading accurately, I checked the operation of the VG actuator. The VG actuator rod moved freely and the diaphragm showed no signs of leaking.

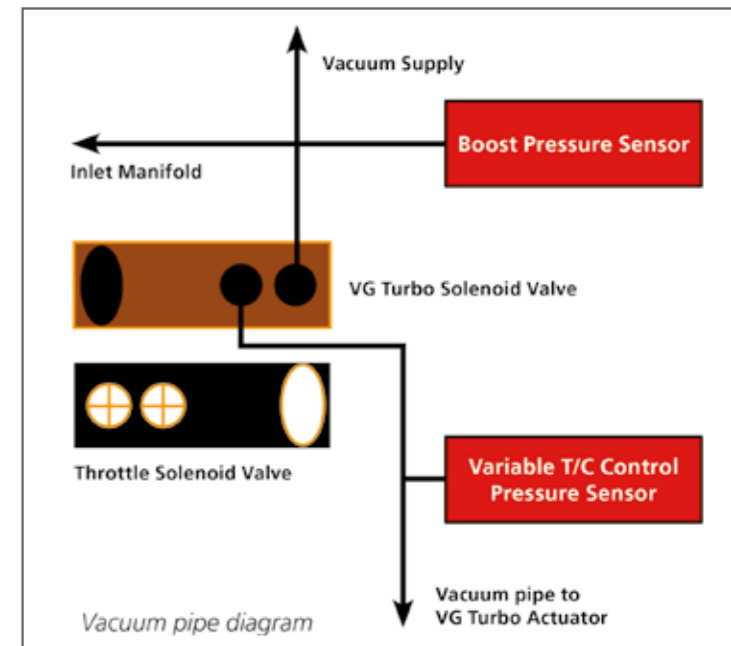
I then checked the operation of the solenoid (Figure 4).

With the solenoid powered up using a 12V battery and suitable connectors, and a vacuum applied to the lower port, with the upper port sealed, the vacuum should be maintained. However, this solenoid valve was not quite holding its vacuum.

The way this valve works is that a vacuum is supplied to the upper port from the vacuum pump. When the valve is switched on by the engine ECU and controlled by PWM (Pulse Width Modulation), it opens the lower port to operate the VG actuator in order to move the deflector blades according to the engine load. This was not happening fast enough due to a slight internal leak on the valve, which made the turbo produce too much boost at the wrong time, resulting in the fault code '49 over boost', causing it to go into 'safe mode'.

After replacing the VG turbo solenoid valve (ADC47220), a road test and recording was required to test if the problem was fixed. Compared to the first recording, the variable turbo charger control pressure is now showing that it is being controlled correctly and the turbo is no longer over boosting. The vehicle was back performing just as it should.
