Blue Print ADBP720055

Mazda 3, 6 and CX-5 equipped with the 2.2 Diesel engine

Exhaust Pressure Sensor

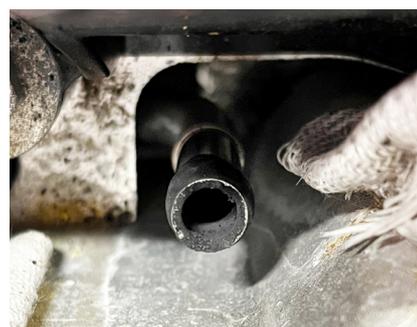
Fig. 4

However, the metal pipe from the exhaust to the sensor is susceptible to becoming blocked with carbon deposits. Therefore, before replacing the sensor, check that the pipe is not blocked.

Unplug the original sensor from the wiring harness and discard. Remove the original rubber hose from the metal pipe and check for carbon deposits. (Fig. 4)
