# Blue Print ADM58099, ADBP800555, ADBP800612

Mazda 2 2016-, 3 2014-2016, 6 2014-2016, CX-3 2016-,  
CX-5 2013-2016, CX-9 2016-

## Anti Roll Bar Bush

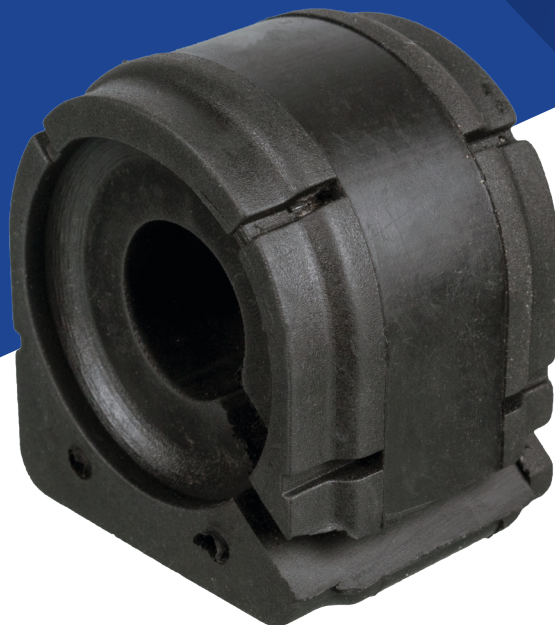
Squeaking noise from the suspension system when travelling over uneven surfaces after the anti roll bar bushes have been replaced or lubricated.

The bushes for the vehicles listed above are designed to be of a grip type which have been incorporated for noise prevention purposes. If any type of grease or lubrication is applied to the bushes during installation, it may create noise due to the bushes slipping on the anti roll bar.

To prevent noise from occurring, never apply any type of grease or lubrication to the front or rear anti roll bar bushes.

When replacing, only install these anti roll bar bushes when clean and dry and do not use any lubricant during the installation process.
