# Blue Print ADS78008

Subaru Forester, Impreza, Legacy, Levorg, Outback, XV, Exiga.

## Control Arm Bush

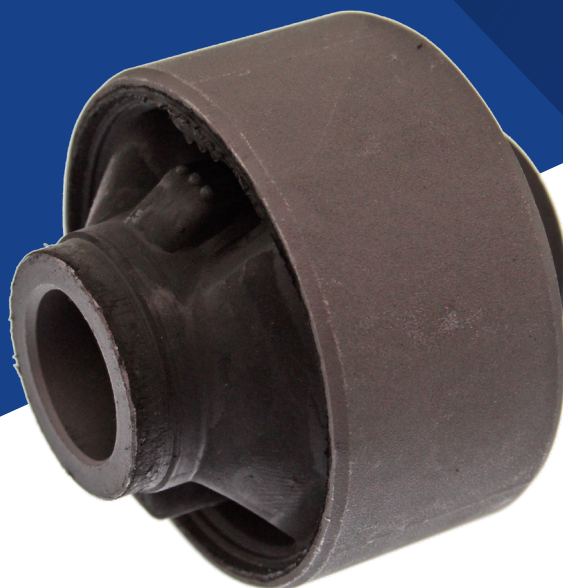
Figure 1

Uneven tyre wear, inconsistent vehicle handling and clonking noise.

Deterioration of the rubber bush, leading to splitting and debonding of the rubber to metal. (Fig.1)

The front suspension lower control arm bushes are available, making this control arm a serviceable part.

Before installing the new bush, it is vital to check that the replacement part is being fitted the correct way up as its orientation is critical for both the operation of the suspension system and the service life of the part.

There are moulded lugs on both sides of the bush, with one larger than the others on one side – this side faces up.

The lugs should be diagonally in line with the ball joint. Therefore, mark the control arm before pressing out the old bush to assist with alignment. (Fig.2)

Press out the old bush with a suitable adaptor. With it removed, clean any corrosion from the control arm where the new bush is going to be installed.

Mark the new bush so that it can be aligned with any premade marks, then press it into the control arm. (Fig.3)

With the new bush installed, refit the control arm and tighten all fixings to the vehicle manufacturer's settings. Carry out a suspension alignment check and adjust as required.
