Fact Sheet

INA Engine KIT 559 0146 10

Engine: FIAT 1.3 | JTD/OPEL 1.3 | CDTI Car Parc: 7.5 million worldwide

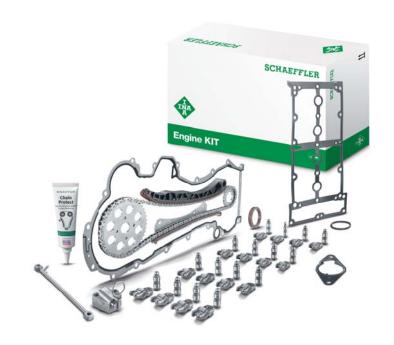
Wear can cause the timing chain to lengthen, which can lead to the chain jumping or, in the worst case scenario, breaking. In addition to damaging the complete timing drive, this usually also causes damage to the valve train.

If, once the chain has broken, the camshaft is no longer driven by the crankshaft [A], the valves remain partially open. The valves are pressed against the finger followers by the pistons [B]. The pistons may also strike the valves if the chain jumps.

As the finger followers are not able to move out of the way, they become deformed. Due to the high load, the hydraulic pivot elements also become damaged (not visible from the outside). The camshaft is not usually damaged. In-depth testing for any additional resulting damage is obligatory, in particular damage to the valves.

Timing chain, tensioner, tensioning rail, guiding rail, toothed gears (on the crankshaft and camshaft), Schaeffler Chain Protect, oil line, pivot elements, finger followers, control casing seal, valve cover gasket, vacuum pump seal, high-pressure pump seal
