# NISSENS' TECHNICAL TIPS

## AC Compressors

**PRODUCT SUBJECT** AC SYSTEM NOT COOLING/  
NOT FUNCTIONING

### VOLKSWAGEN T5 FULLY AUTOMATIC AC SYSTEM

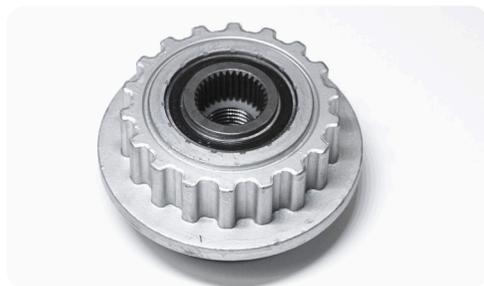
Photo 1

**Damaged freewheel** - Poor maintenance of the power steering pump and the air condition compressor causes damages to the GATES clutch (torn or cracked teeth).

- Make sure that the GATES clutch does not have any visual damages.
- Make sure that the overload protection does not prevent the compressor from turning the freewheel. By movement or blocks in either direction, replace the freewheel with OT no. 070 903 201 C (photo 1).
- Do not replace a fully functioning AC compressor when the freewheel is defective.
- Replace the damaged GATES clutch with OT no. 070 903 327 (see photos 2 & 3).
- Check if sleeves and mounting dowels on the bracket are worn. Furthermore, check if bracket dimensions are accurate.
- By measurement of 60 mm +/- 5.5 mm (measured without sleeves), replace
