Caution, when the Wheel Bearing Kit  
VKBA 1440

VKBA 1440

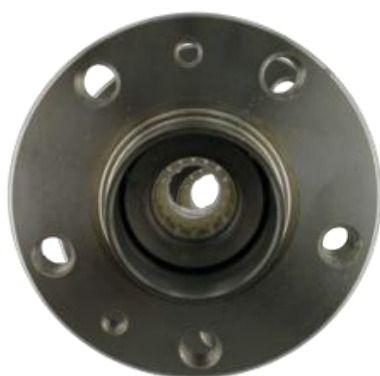
SKF use safe packaging solutions to protect the wheel bearing from damage during transport or mounting. VKBA1440 is delivered with a plastic joining sleeve, to keep the inner rings together, until the bearing is mounted on the car.

Bearing with plastic joining  
sleeve

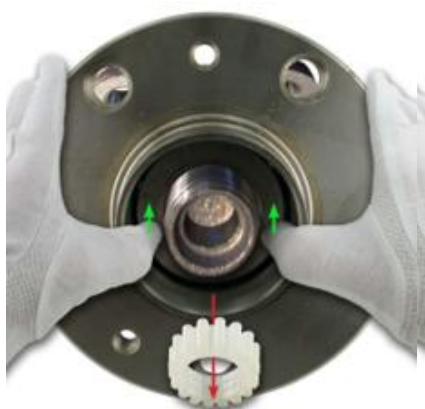
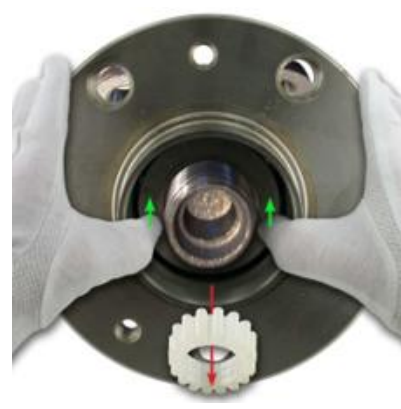
The plastic joining sleeve ring will be automatically pushed out by the axle stub, when mounting the bearing in a correct way, applying the force on the inner ring. Do not push out the plastic sleeve manually before mounting.

- Never remove plastic sleeve before mounting the bearing, as this will separate the inner rings
- Always use correct mounting tools
- Apply the correct force on the bearing inner ring

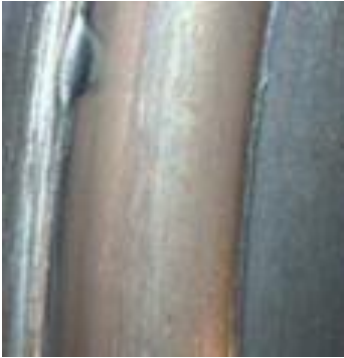
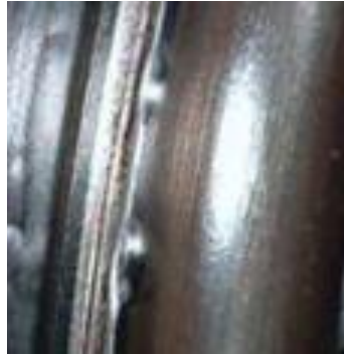
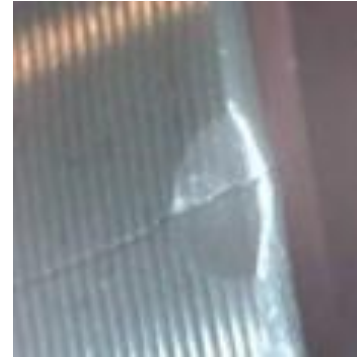
## VKBA 1440 - TROUBLESHOOTING

- Wrong tools used
- Wrong mounting
- Wrong applied force

- Bearing inner rings could be separated, despite the plastic secure ring
- Bearing outer rings can move out of the bearing due to the press fit, when the shaft gets pushed through the inner ring
- The balls and raceways will get damaged as the mounting force is transmitted through the balls and raceways.
- Premature bearing failure/damage (due to water ingress....)

- Use correct tools for a proper mounting
- Apply correct force
