SPIN DOCTORS...

The Mitsubishi L200/Straker pick-up is well known for its ruggedness and load lugging capabilities. The example in question is a 2003 model, which is regularly put to work pulling a mini digger in addition to other ground work duties. The vehicle has covered over 225,000 kilometres and was still going strong; until a few months back.

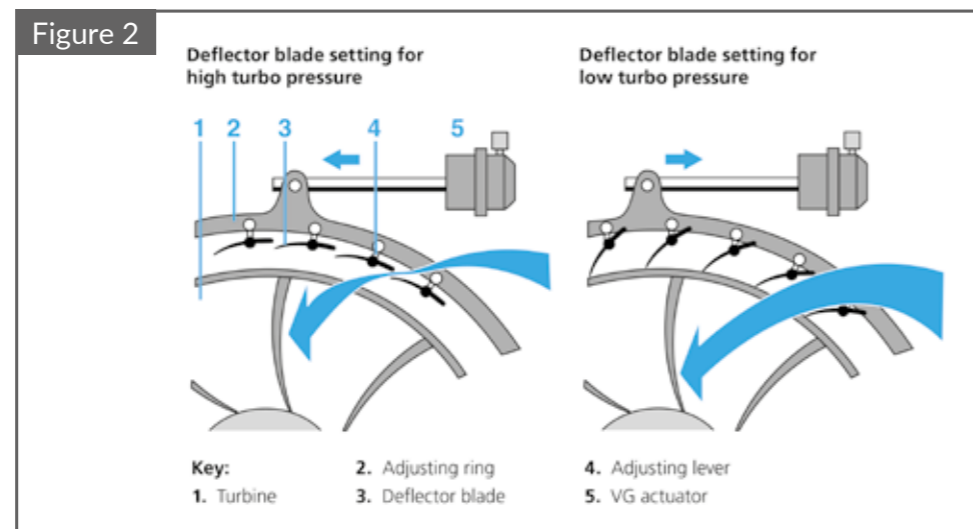
The deflector blade angle is adjusted by turning an adjuster ring (Figure 2). This then sets the deflector blades to the desired angle. On this L200 the adjuster ring is operated by an actuator which is controlled by a solenoid valve, this is then controlled by the engine ECU. Thus the turbo pressure can be adjusted to the optimum setting in response to a range of inputs.

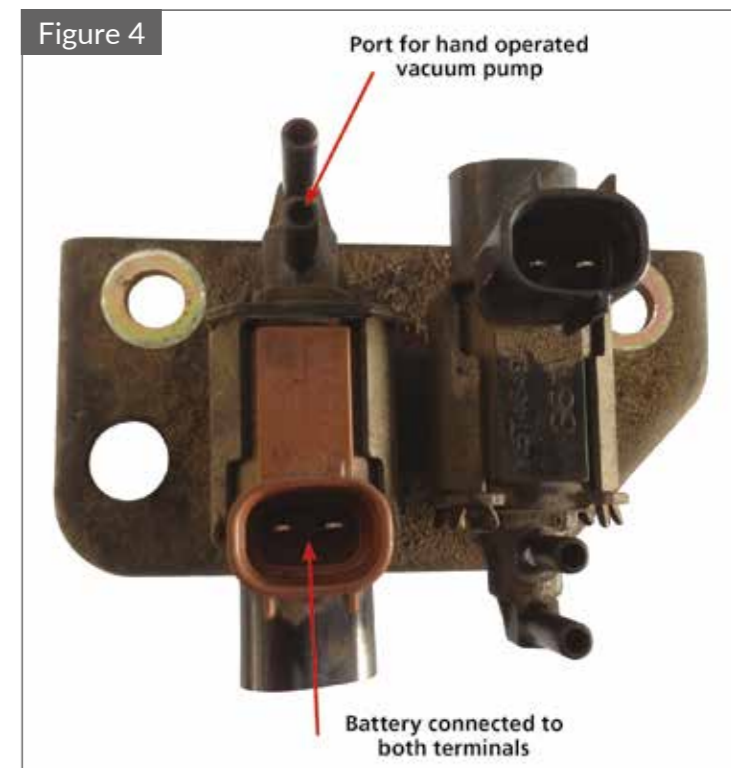
I then checked the operation of the solenoid (Figure 4).

With the solenoid powered up using a 12V battery and suitable connectors, and a vacuum applied to the lower port, with the upper port sealed, the vacuum should be maintained. However, this solenoid valve was not quite holding its vacuum.

The way this valve works is that a vacuum is supplied to the upper port from the vacuum pump. When the valve is switched on by the engine ECU and controlled by PWM (Pulse Width Modulation), it opens the lower port to operate the VG actuator in order to move the deflector blades according to the engine load. This was not happening fast enough due to a slight internal leak on the valve, which made the turbo produce too much boost at the wrong time, resulting in the fault code '49 over boost', causing it to go into 'safe mode'.

After replacing the VG turbo solenoid valve (ADC47220), a road test and recording was required to test if the problem was fixed. Compared to the first recording, the variable turbo charger control pressure is now showing that it is being controlled correctly and the turbo is no longer over boosting. The vehicle was back performing just as it should.
