Blue Print ADBP720055

Mazda 3, 6 and CX-5 equipped with the 2.2 Diesel engine

Exhaust Pressure Sensor

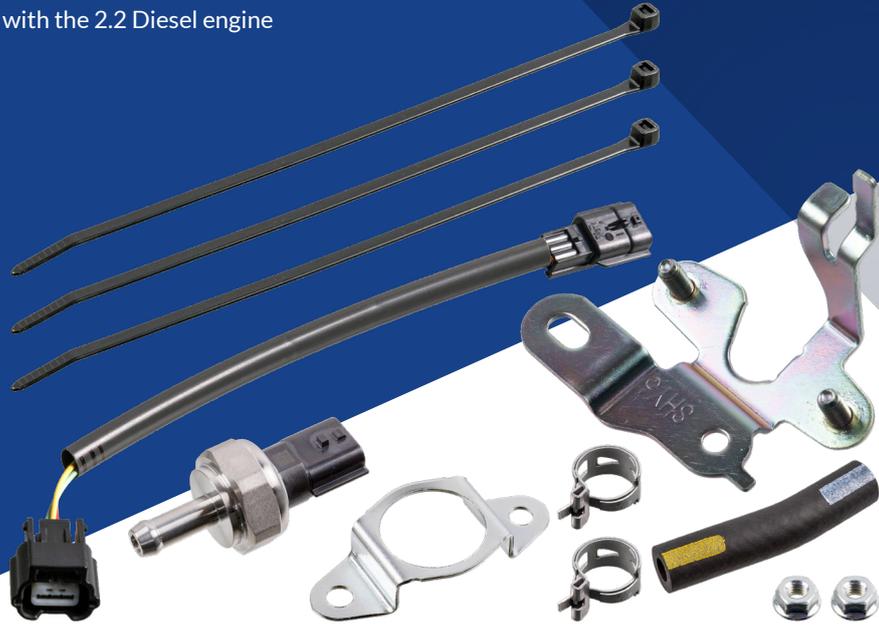
Exhaust pressure sensor is faulty, or the pipe from the exhaust to the sensor is blocked with carbon deposits.

To replace the sensor, first remove the plastic engine cover, then unplug the electrical connectors to some of the injectors so that it is easier to gain access to the exhaust pressure sensor. (Fig. 1)
