febi 196827, 1000002, 1000003, 1000004

To fit: Various Citroën, DS, Peugeot, Fiat, Ford, Toyota, Vauxhall and Opel models fitted with the four-cylinder 16 valve 1.5 HDi engine.

Timing Chain and Camshaft Kits

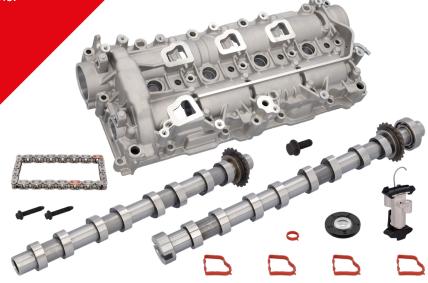
The vehicle manufacturer introduced a reinforced timing chain to address this issue, increasing the size of the chain and camshaft sprockets.

To identify which camshaft drive chain is fitted, locate the part number for the camshaft carrier which can be found near the oil filter. The part number for vehicles fitted with the 7 mm camshaft chain drive is 9812647280, and for vehicles with the 8 mm camshaft chain drive it is 9830580480.
