Subaru Forester, Impreza, Legacy,  
Levorg, Outback, XV, Exiga.

## Control Arm Bush

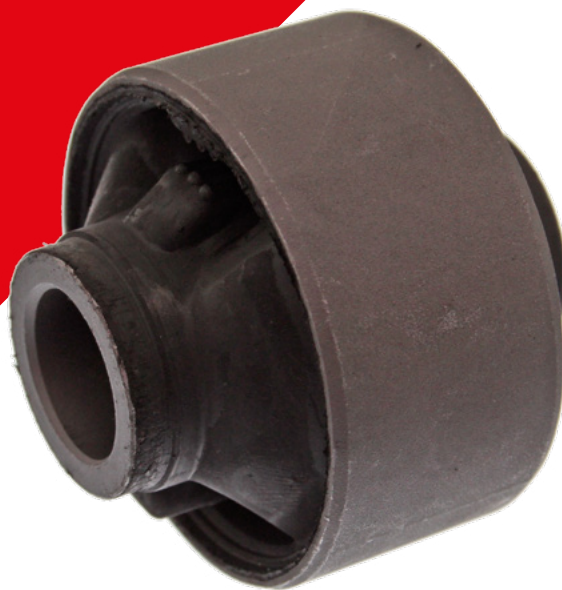
Fig. 1

Deterioration of the rubber bush, leading to splitting and debonding of the rubber to metal. (Fig.1)
